CASE STUDY

Auto Intake Manifold Cleaning

Product: AquaVantage® 815 GD-NF

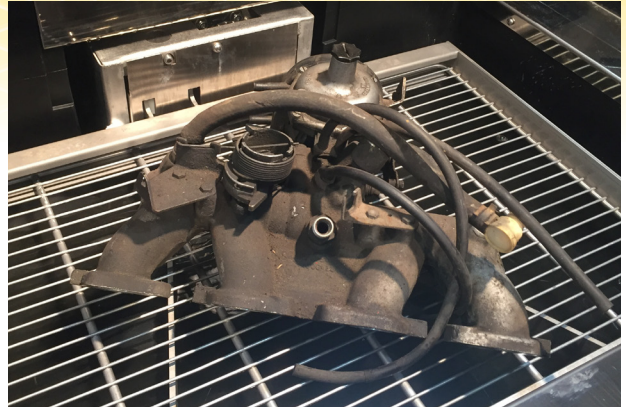
Before

Removing What Soil: Oil, particulate, carbon, ambient soils.

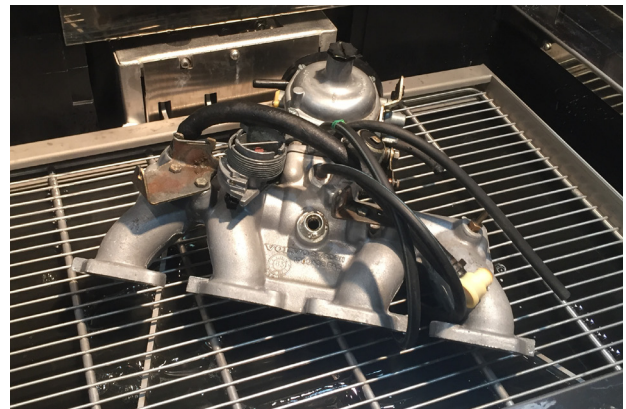
After

Results: Parts are clean, undamaged, restored to original condition.
